The red mud pond dam failure at Ajka (Hungary) and subsequent developments

György (George) Bánvölgyi
Senior Process Consultant, Alumina
Bán-Völgy Limited Partnership, Budapest, Hungary
E-mail: gbanvolgyi@gmail.com

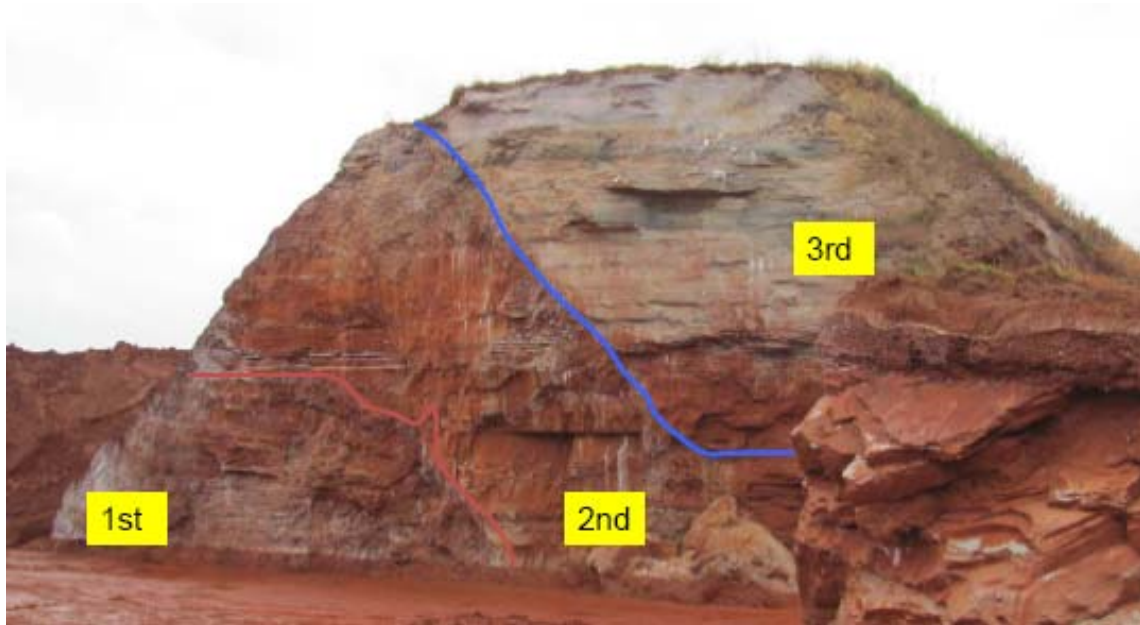
Fig. 4 Stages of building of the dam⁸

It can be concluded that the material of the dam is highly variable, with sacks of sand and clay. The clay can react with the caustic content of the liquid phase being stored in the red mud pond, however this reaction is slow¹¹. Debris from an earlier construction stage can also be detected. All of these negatively affect the integrity of the dam material.

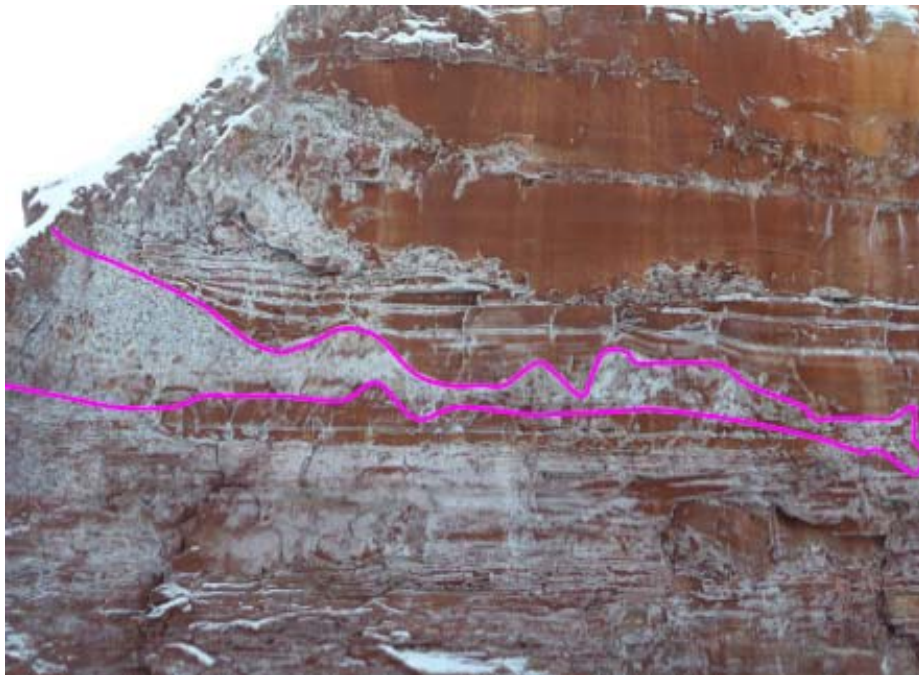
Fig. 5 Caustic corrosion sack in the dam. The caustic containing supernatant liquor seem to have penetrated into and through the sand layer.⁹

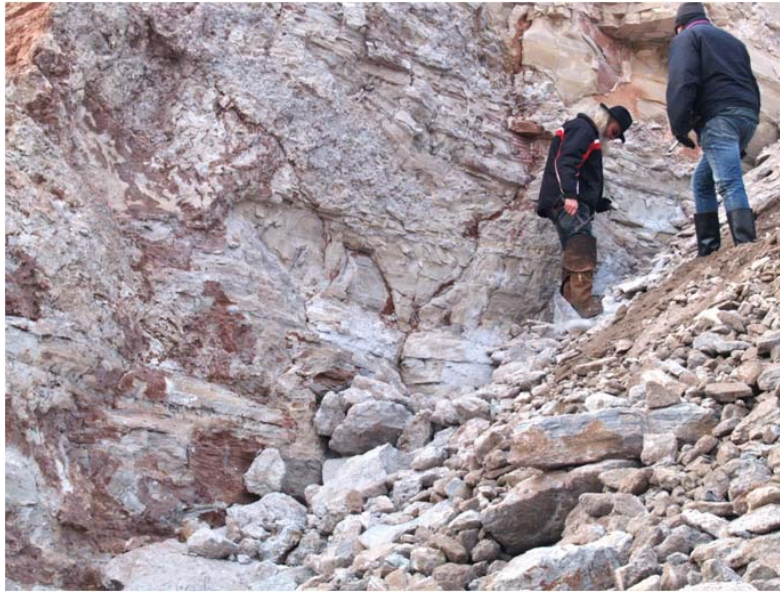
**Fig. 6 Western wall having removed the fresh surface of the break.
Open fissures with dislocations of a size of dm¹⁰**

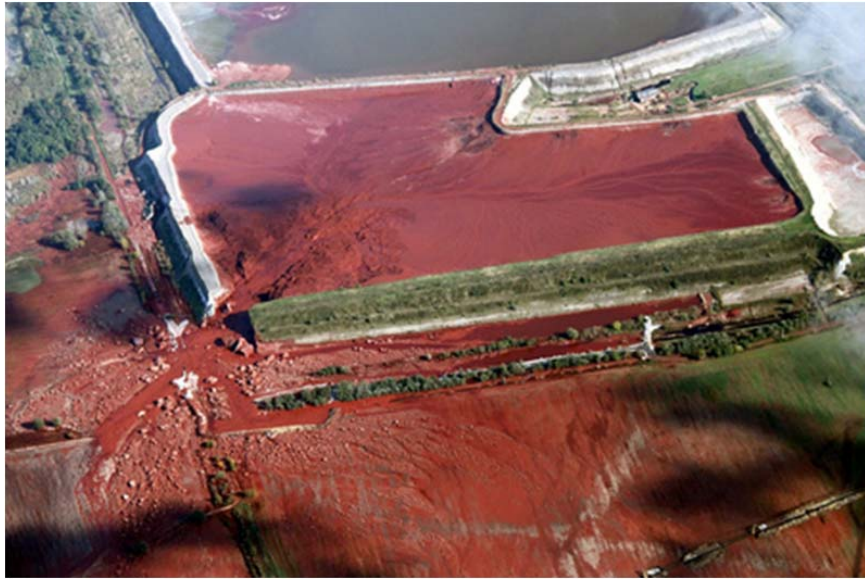
Fig. 9 Aerial photo of the Reservoir No. 10 after the dam failure in October 2010²⁵

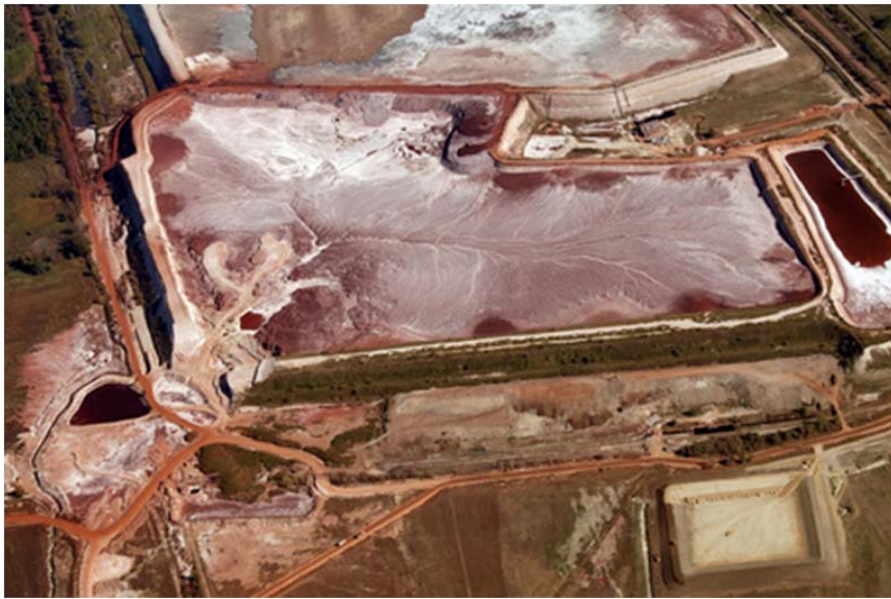
Fig. 10 One year later. Dry mud stacking of press filtered bauxite residue.

Filter presses were implemented in the Ajka refinery early 2011. The moisture content of the bauxite residue filter cake thereby is believed to be 30-35%. Some gypsum is added to the washed press-filtered bauxite residue to adjust its pH between 10 and 11. New phenomena is the dusting of the dry mud stacking during windy weather, this has not been kept under control as yet²⁴.
